Monitoring Data Record

Project Title: R-2417BA (Sites 14 and 22) COE Action ID: 2002-2-0899

Stream Name: UT Bull Run DWQ Numbers: 001432

Monitoring Quarter: ( 6 ) of 8

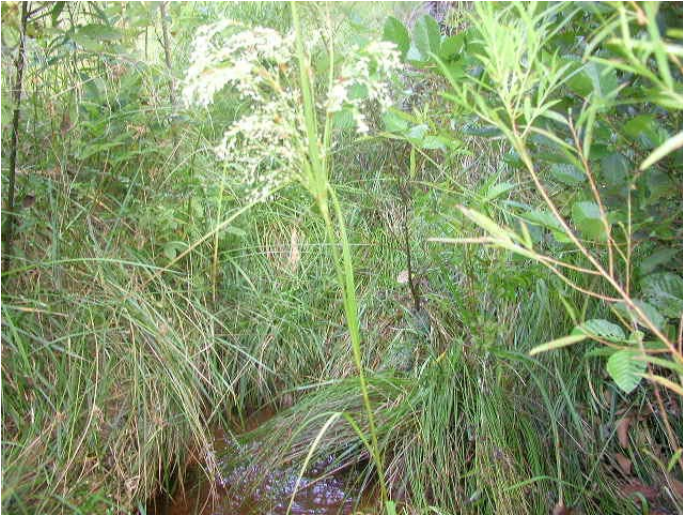
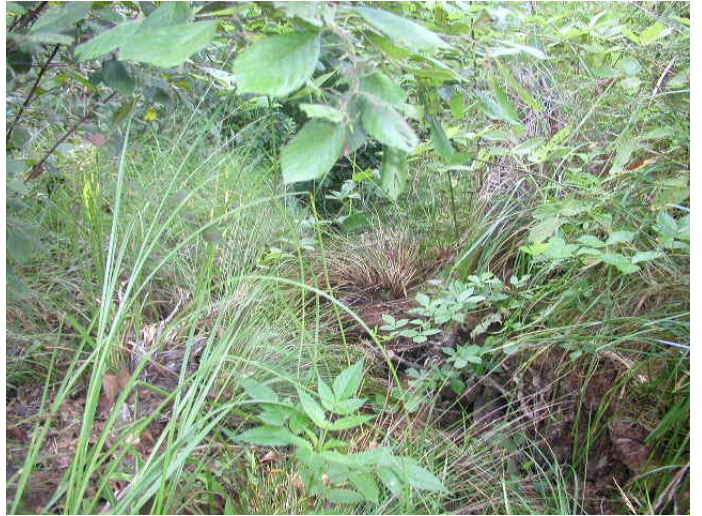
# Site 14

Site 14 stream relocation at Sta. 133+90 LT. has a slight headcut where the relocated stream ties back to the existing stream. The site is stabilized and will continue to be monitored.

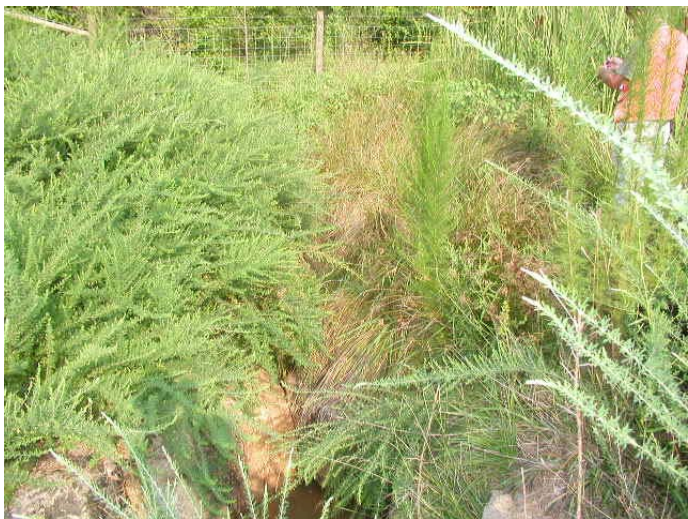
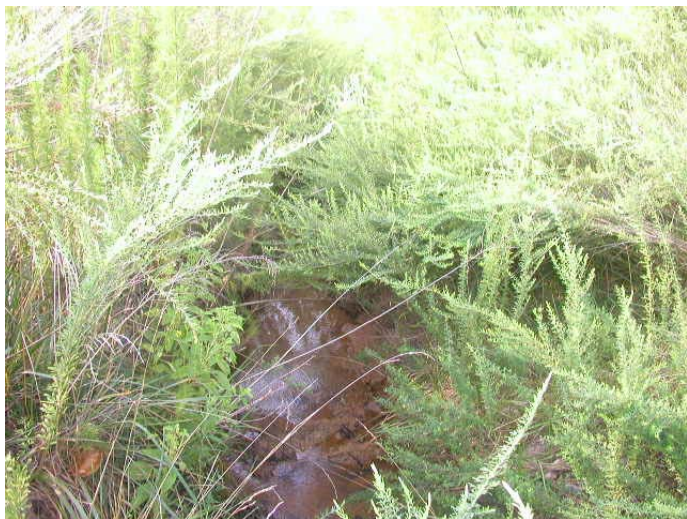
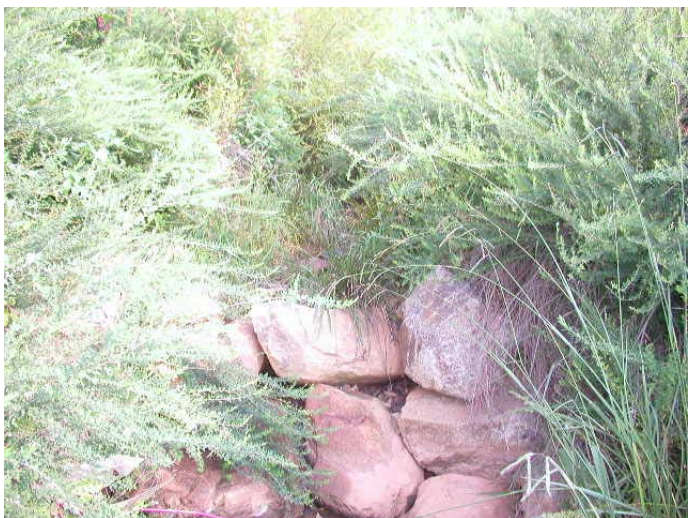
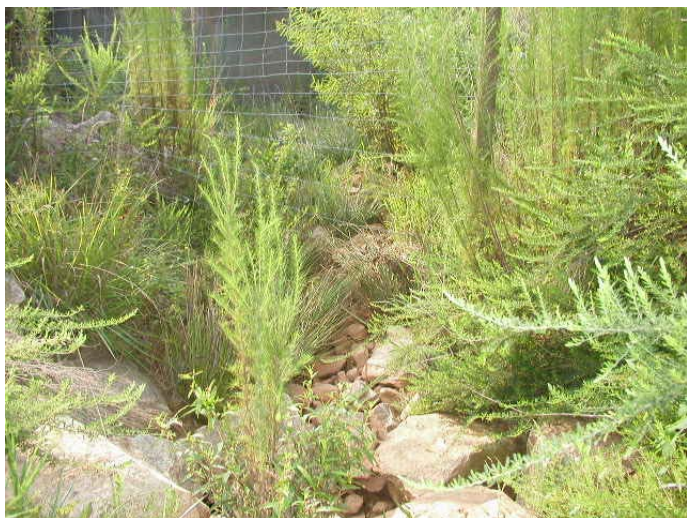
# Site 22

Site 22 stream relocation at Sta. 146+00 RT. has two cross vanes that were constructed without filter fabric per the plans. Water is currently flowing through the structures. There has been some localized erosion but the site has stabilized with vegetation. NCDOT will continue to monitor the site.
